<b>REPORT TITLE:</b>	<b>REMEDIAL WORKS SUMMARY &amp; VALIDATION</b>
<b>At:</b>	<b>10 &amp; 12 Bangor Street Y Felinheli Gwynedd LL56 4JD</b>
<b>Performed By:</b>	<b>Randall &amp; Walsh Associates Ltd 1<sup>st</sup> Floor Offices Michael Ward Lynstock Way Lostock Bolton BL6 4SA</b>
<b>Project Reference:</b>	<b>07RB239</b>
<b>On Behalf of:</b>	<b>Quest Gates Ltd 3<sup>rd</sup> Floor Sussex House 21-25 Lower Stone Street Maidstone ME15 6YT</b>
<b>Written by:</b>	<b>Catherine Shannon</b> Environmental Geologist
Signature	  _____
<b>Approved by:</b>	<b>Jon Burton</b> Technical Director
Signature:	  _____
<b>Issue Status:</b>	<b>Final</b>
<b>Date:</b>	<b>10 August 2009</b>

Randall & Walsh Associates (RAW Group) were instructed by Quest Gates Ltd to proceed with remedial works and site validation at No's 10 & 12 Bangor Street, Y Felinheli, Gwynedd (Appendix A, Figure 1). Remedial works were required in order to address the release of an unknown quantity of domestic heating oil (kerosene) from the boiler or feed line at No. 10.

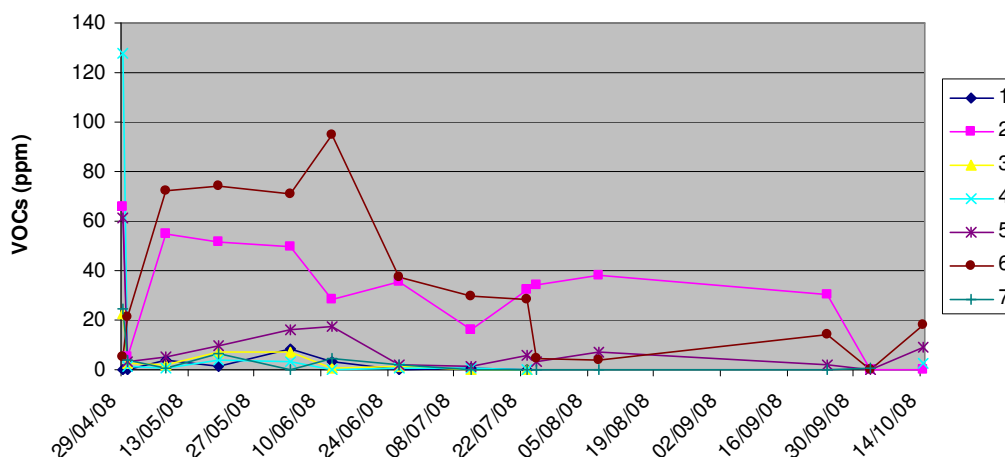
**Graph 1: VOC concentrations measured in SVE extraction points 1 -7 within in-situ treated soils**

Graph 1 below provides an illustration of the general reduction in VOC concentrations determined using a MiniRae 2000 Photo-ionisation Detector (PID) calibrated on 100ppm isobutylene, used to obtain measurements from each SVE extraction point in the soils over the treatment period.

Graph 1 above and the graphs provided with the summary data sheets in Appendix E confirm the reduction in VOC concentrations during the SVE treatment of the soils and structures at both No.10 and No.12 Bangor Street.

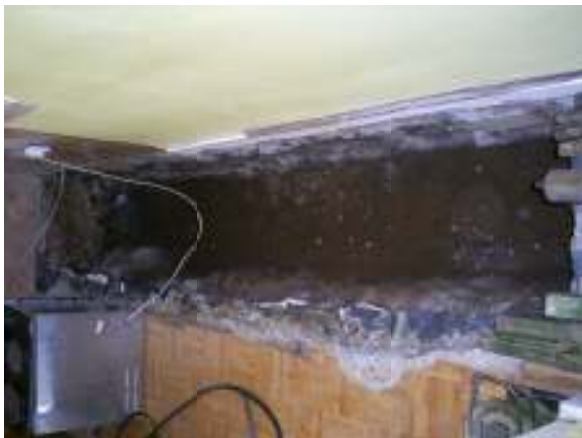
**Photograph 2:** The excavated floor in the kitchen of No. 12 to remove impacted soils to foundation level.

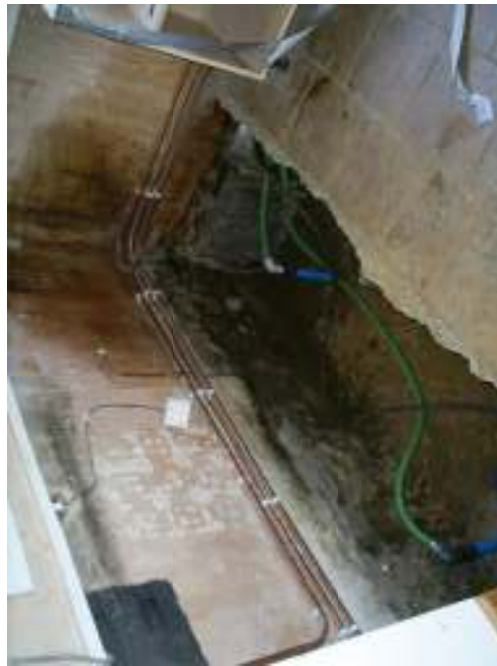
**Photograph 4:** Two SVE points installed in the soils within the kitchen of No.10.

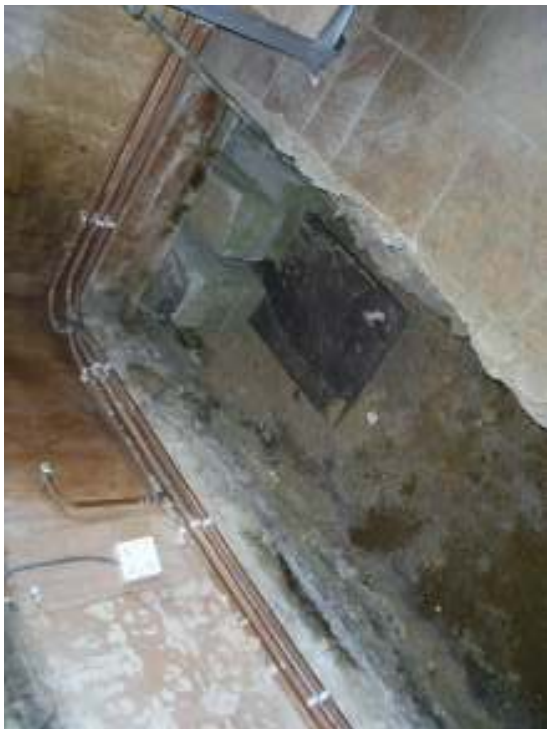
**Photograph 1:** The excavated floor in the kitchen of No. 10 to remove impacted soils to foundation level.

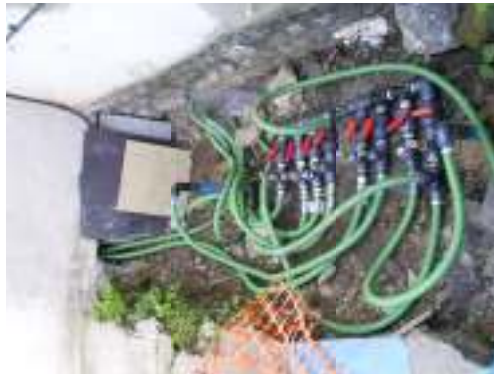
**Photograph 3:** View of the exterior SVE system to treat soils beneath the ground.

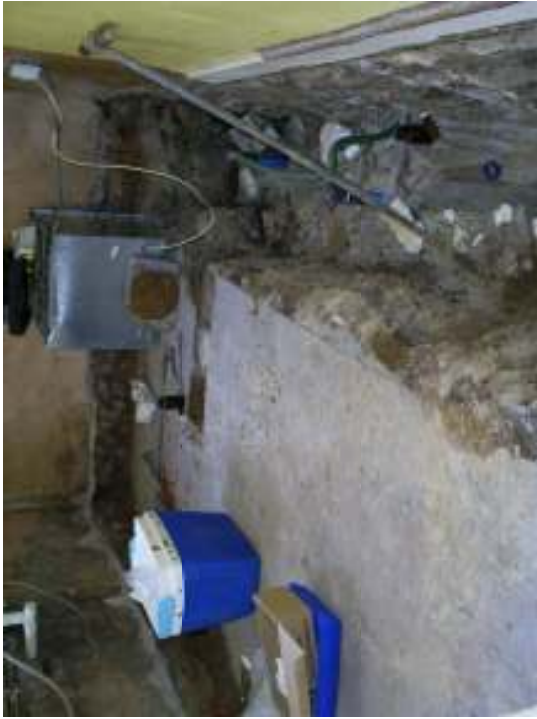
**Photograph 5:** View of the SVE points installed into the soils within the kitchen of No. 12.

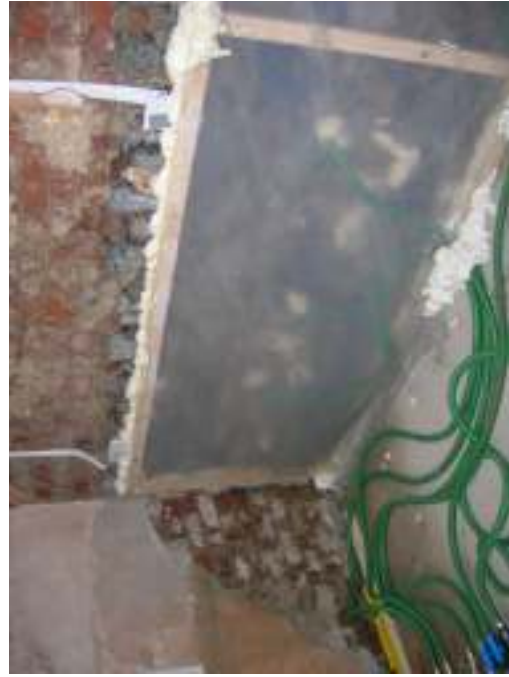
**Photograph 7:** View of the SVE system installed into the wall within property No. 12.

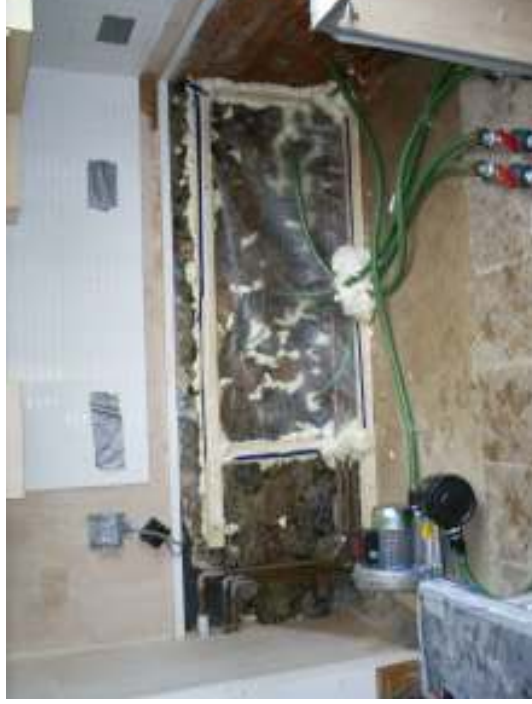
**Photograph 6:** View of the SVE system installed into the wall within property No. 10.

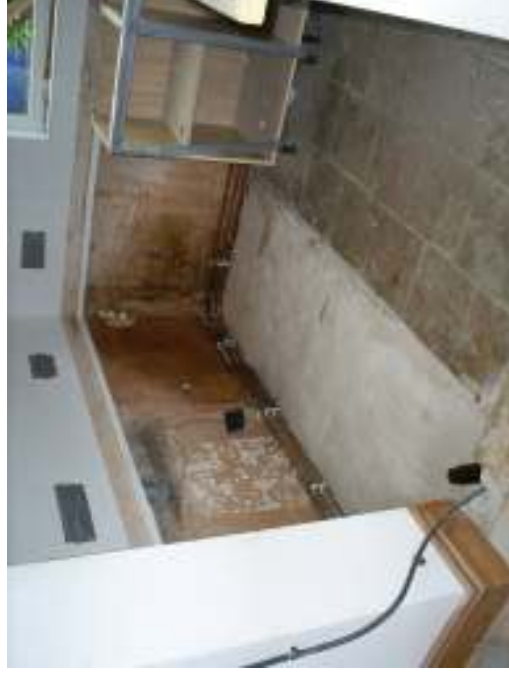
**Photograph 8:** View of the reinstated kitchen floor and wall in property No.10.
